**CREEP OF HI-NICALON S FIBER TOWS
AT ELEVATED TEMPERATURE IN AIR AND IN STEAM**

THESIS

AFIT-ENY-13-M-31

AIR FORCE INSTITUTE OF TECHNOLOGY

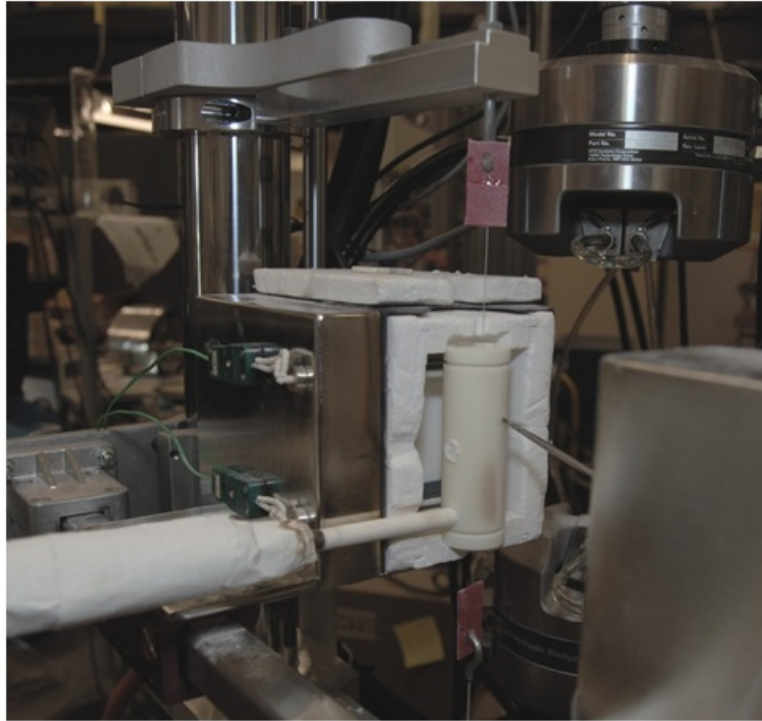
Figure 4.3: Experimental setup for creep testing of fiber tows with alumina test chamber and steam feeding tube. Reproduced from [2]

Figure 4.3 shows the alumina test chamber set in one half of the furnace with the steam feeding tube entering the test chamber at the bottom and a fiber tow specimen suspended from an extendable fixture of the creep testing facility.
